## MPC8315E Chip Errata

This document details all known silicon errata for the MPC8315E, MPC8315, MPC8314E, and MPC8314. The following table provides a revision history for this document.

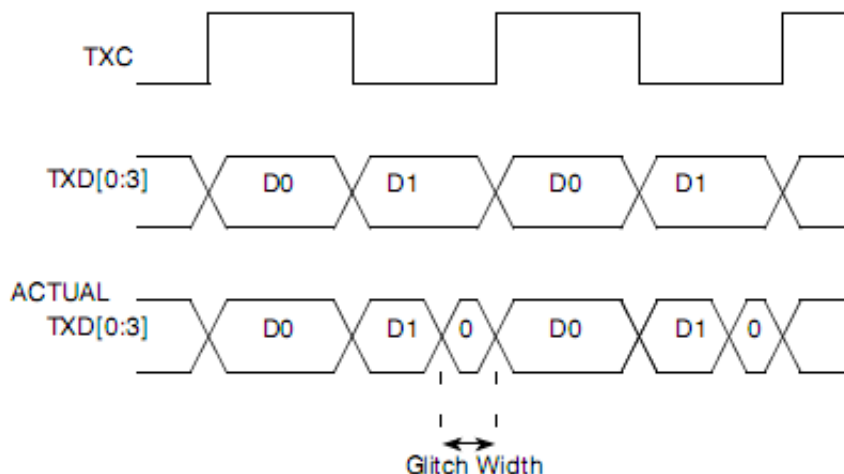
**Figure 1. RGMII AC Timing diagram**

In RGMII 1000 mode, where TXD switches at both the edges of the clock (TXC), AC spec is not met for the higher nibble (D1) of data txd[0:3]. Data corruption occurs because of a glitch, which causes data to become Zero. So the data valid time for the higher nibble (D1) is reduced by the width of the glitch.

Effective data (D1) valid width for etsec2 =  $4\text{ns} - 0.9\text{ns} = 3.1\text{ns}$

This may lead to AC specification violation at the PHY and incorrect data capture. Also, RGMII 1000 may not work correctly.

**Impact:** RGMII mode may not be functional, if external RGMII PHY requires a tighter specification.

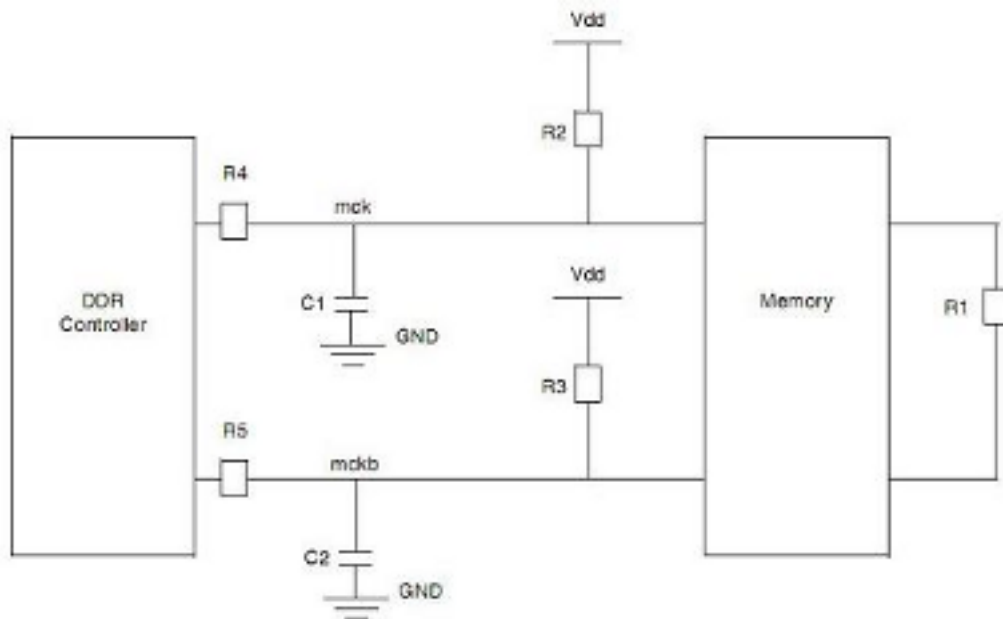
**Figure 2. Recommended connections for DDR controller and memory**

**Impact:** Disagreement with the JESD79-2C standard.

**Workaround:** To meet the JESD79-2C crosspoint voltage specifications, we recommend implementing the following connections between the DDR controller and DDR2 memory:
